**MUSTBE**

## **D.3.3.1. NBS efficiency report**

MUSTBE - *Multidimensional storm water treatment in urban areas for cleaner Baltic Sea* project

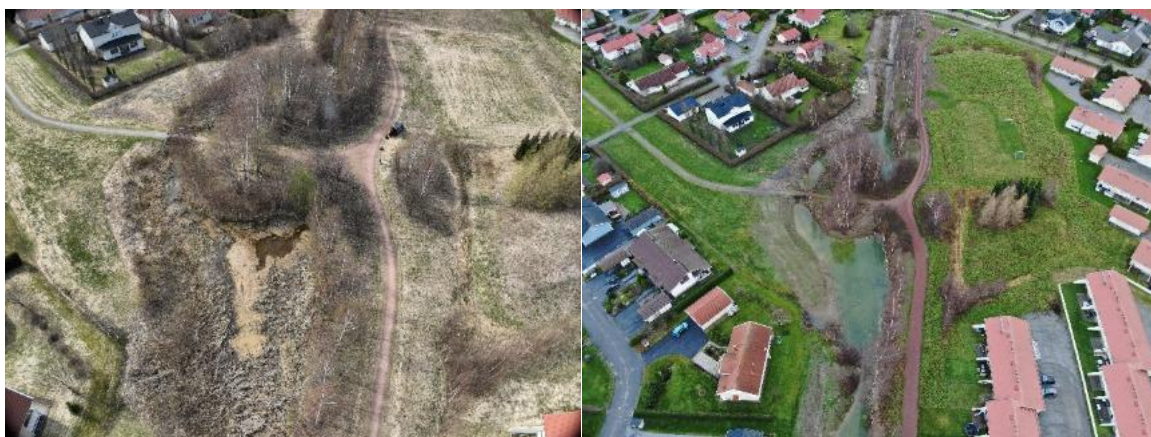
*Figures 1 and 2. Wetland Before and After Construction*

Acid sulfate soils are the main challenge: exposure acidifies soil, leaching metals into the wetland (acidic, metal-rich water flows untreated downstream). Solutions include two stone dams (slow flow, promote sedimentation), two central filtration dams (biochar/gravel bind metals), and a final hollowstone/pumice dam (raises pH, precipitates metals).

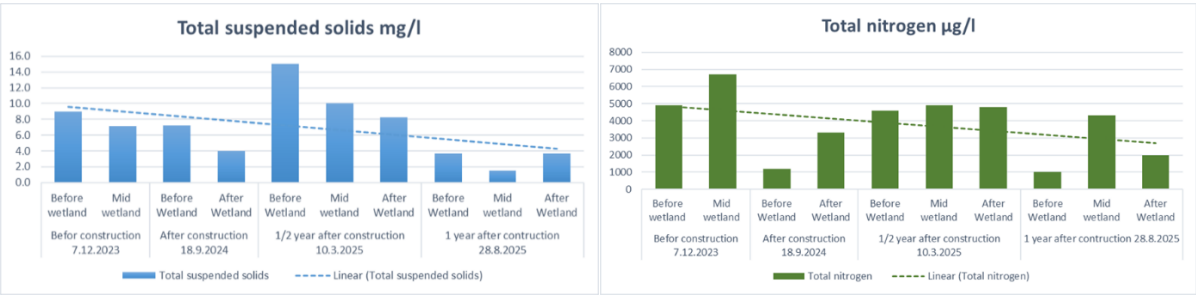
Figure 5. Total Suspended Solids

Figure 6. Total Nitrogen

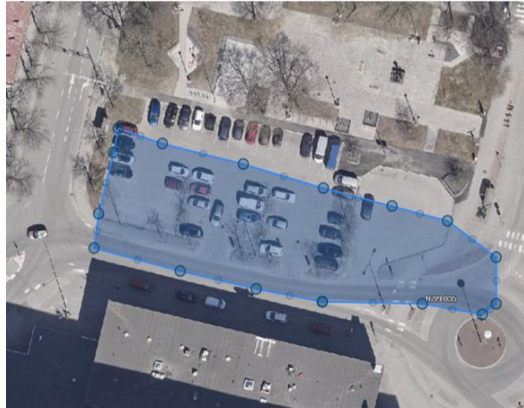
Figure 7. Parking Lot – Ortophoto Overview

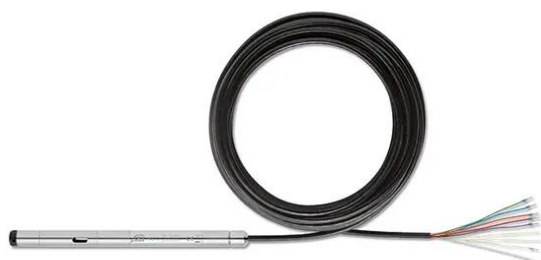
Figure 9. Pressure Level Sensor<sup>1</sup>

Two EC-5 soil moisture sensors are installed at different heights in the stormwater basin. An OTT Hydromet OTT PLS-C measures water table variations, temperature, electrical conductivity (calculating TDS/PSU). Sensor readings are recorded every 5 minutes. The measurement well is equipped with sensors that record electrical conductivity, salinity, water temperature, suspended solids, water level (via pressure sensor), and overflow (calculated from level data).

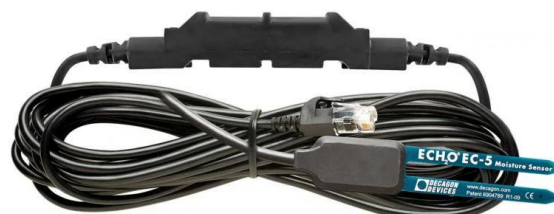
Figure 10. EC-5 Sensor<sup>2</sup>

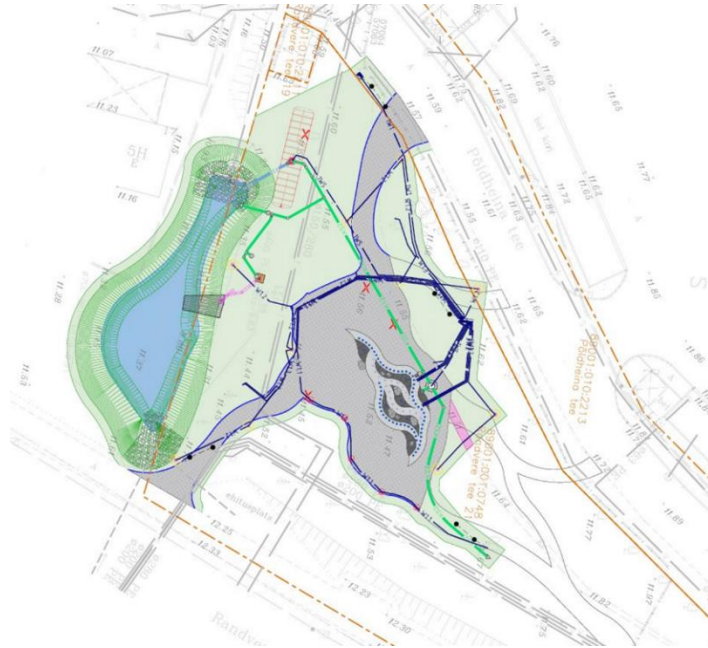
*Figure 14. Viimsi Pilot Site Schematic Overview*

The Viimsi pilot site is located at Randvere Road 21 in Haabneeme Parish, Estonia, covering an area of 0.35 hectares owned by Viimsi Municipality. The stormwater system catchment area is 11.6 ha. The site is situated near Lubja cliff, which discharges significant volumes of groundwater year-round, contributing to frequent flooding during heavy rainfall and snowmelt. Additionally, runoff from nearby traffic junctions introduces pollutants into the stormwater system, which ultimately degrades the water quality of the Baltic Sea. To address these challenges, the municipality is implementing a smart, nature-based stormwater management system that includes a stormwater pond with a sedimentation trap and a weir for water level adjustment, a water cascade, interactive elements, and a stormwater-

fed fountain. The system is designed to slow peak flows, improve water quality, and demonstrate how stormwater can be reused in urban environments.

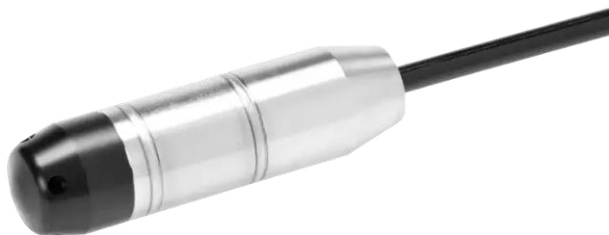
Figure 15. Huba Control Type 681 Level Sensor<sup>3</sup>

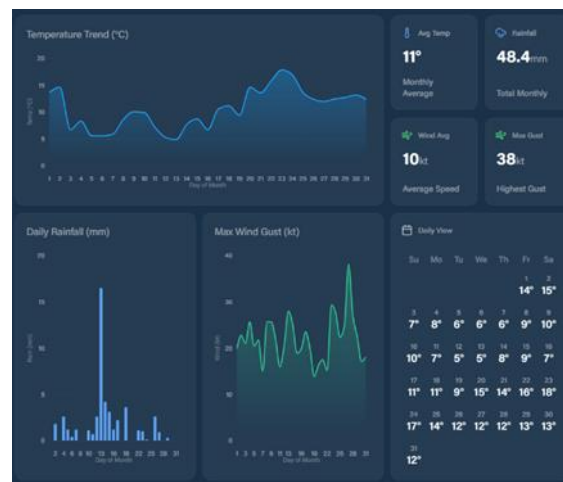
Figure 23. Soderhamn Weather Indicators, May 26, 2026<sup>7</sup>

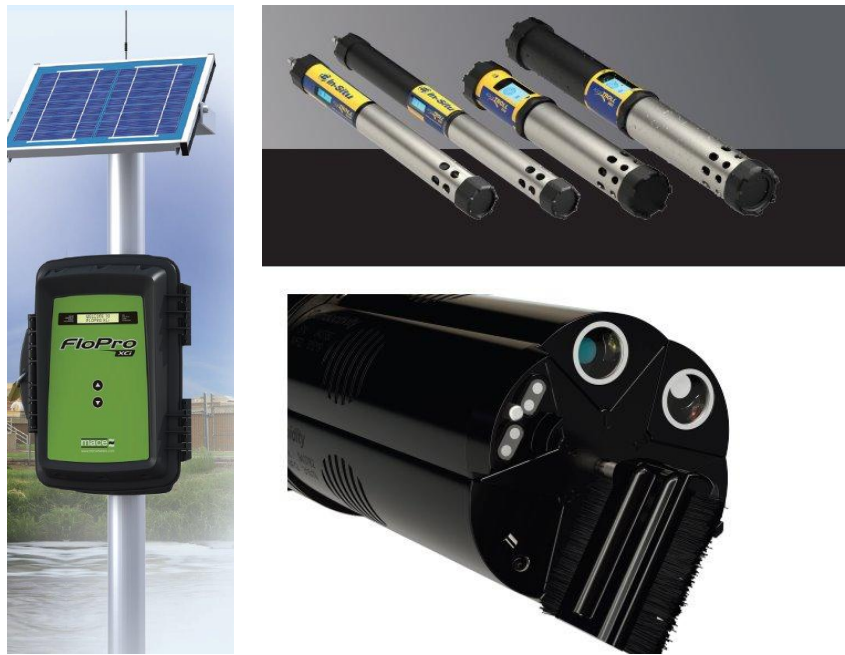
*Figure 30. In-Situ Aqua TROLL® Multiparameter Sonde units, 2260 Ultrasonic Level Transmitter<sup>9</sup>, FloPro XCi controllers<sup>10</sup>*

Data acquisition is carried out using two network-powered sensors, which provide real-time monitoring and transmit data directly to AS Tallinna Vesi's SCADA system for internal access only. The setup includes In-Situ Aqua TROLL® Multiparameter Sonde units, 2260 Ultrasonic Level Transmitters, and FloPro XCi controllers.

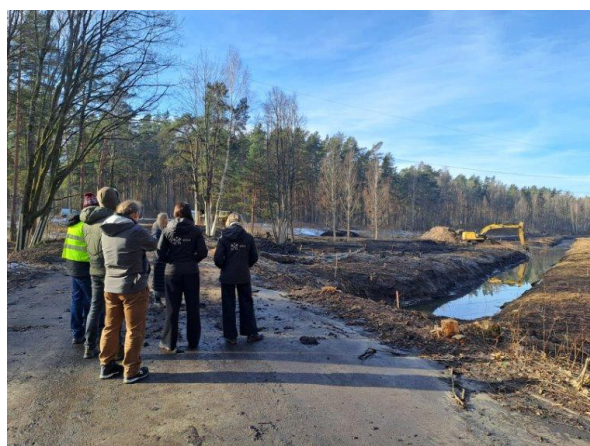
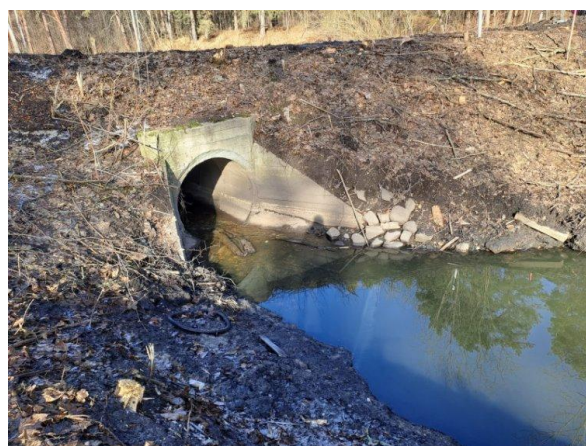
Figures 35 and 36. Šmerļupīte Pilot Site during construction

The solution divides the area into two functional zones - stormwater treatment zone, which includes sedimentation ponds and reed filtration beds, and renaturalisation zone, features meandering stream paths, wet meadows, and phytoremediation vegetation.

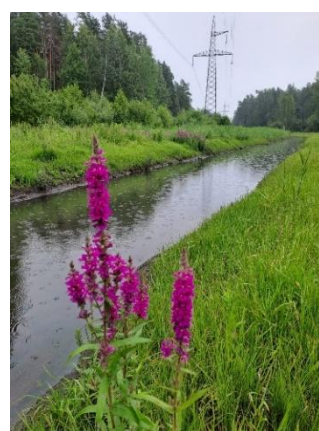
Figures 38. Šmerļupīte Pilot Site after construction

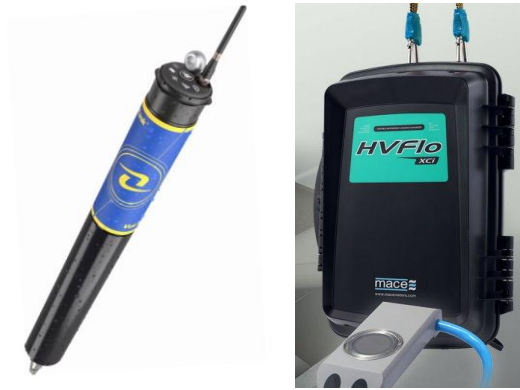
Figure 39. In-Situ VuLink CI + AquaTroll 800 Multiparameter Sonde<sup>12</sup> and Macemeters with different components<sup>13</sup>

The "Willsensors" system stores data in the Rīga Municipality data warehouse, with Power BI dashboards available upon request for internal purposes and the option to publish to the open data portal if needed; transmission frequency ranges from 1 minute to 7 days. It features In-Situ VuLink CI + AquaTroll 800 Multiparameter Sonde units (monitoring temperature, conductivity, pH/ORP, turbidity, nitrates, ammonium, dissolved oxygen, and hydrostatic level), alongside Macemeters with Mace FloSeries3 + Doppler card + WebComm 4G, including HVFlo XCi + Doppler + PolyMount components.

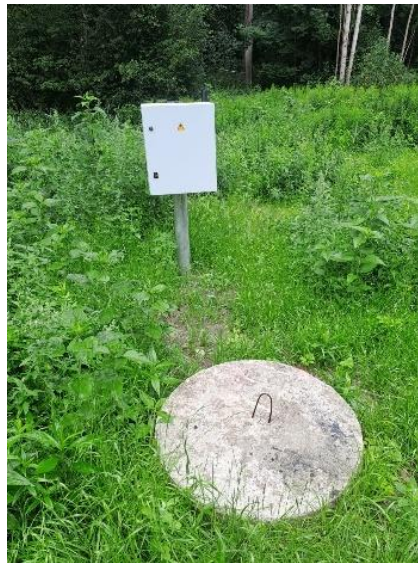
Figure 40. Sensor Power Connection and Monitoring Well
